Overview of the 1st Quarter 2007 Surveillance and Maintenance Report for the DOE LM Rocky Flats Site

Rocky Flats Stewardship Council

August 6, 2007

Rocky Flats Site Surface-Water Monitoring and Operations

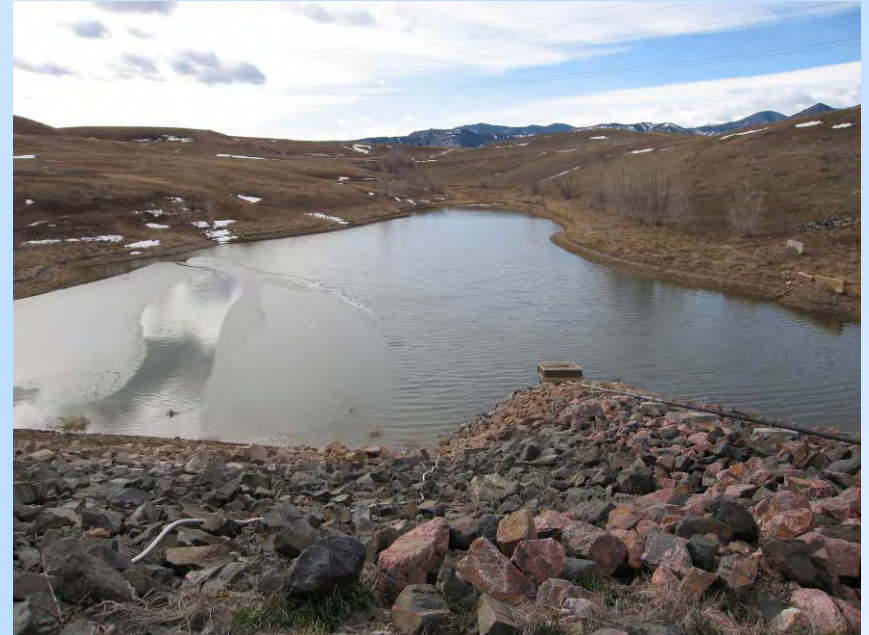
Current Pond Levels (8/2/07)

- Terminal Pond Discharges
 - Pond A-4; 3/1-3/13; 10.25 MG
 - Pond B-5; 3/1-3/13; 7.47 MG
- Transfers
 - A-3 to A-4
 - 1/10-1/24; 5.68 MG
 - 2/7-2/12; 4.95 MG
 - 3/13-3/28; 7.67 MG
- Pond Levels
 - As of 3/31/07 Ponds A-3, A-4, B-5, C-2, and the Landfill Pond were holding approximately 21.8 MG (22.1% of capacity)

- Landfill (20.9%)
- A-3 (21.3%)
- A-4 (11.5%)
- B-5 (23.9%)
- C-2 (19.6%)

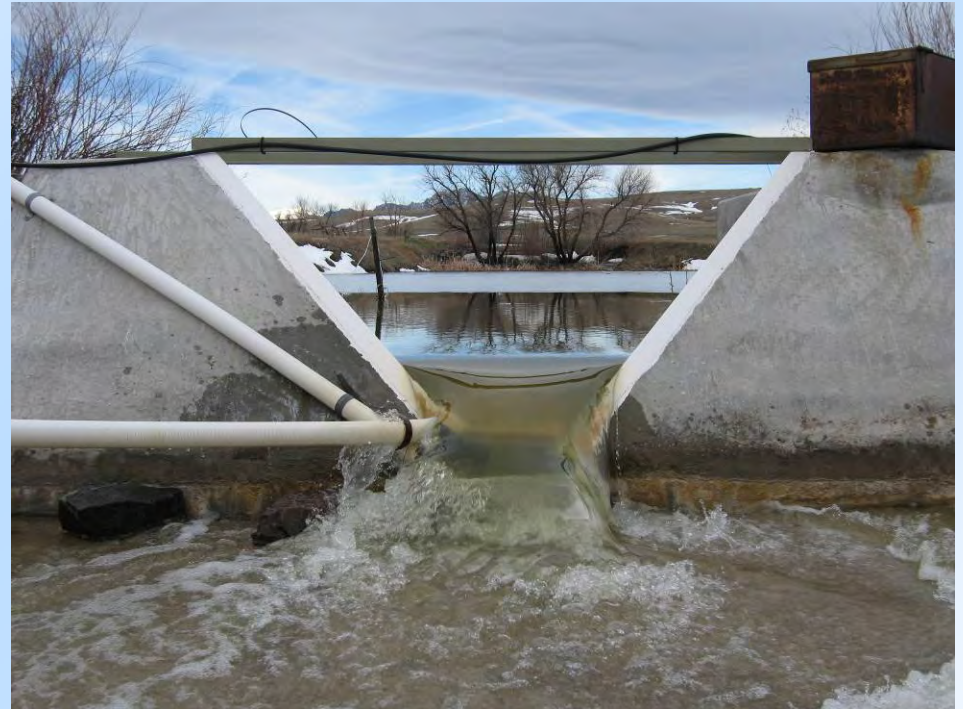
Hydrologic Data – 1st Quarter CY07

- Precipitation
 - 3.14” total precipitation
 - 231% of WY93-06 average
- Flow Rates (percent of average)
 - GS01 (366%)
 - GS03 (126%)
 - GS10 (107%)
 - SW027 (254%)
 - SW093 (258%)

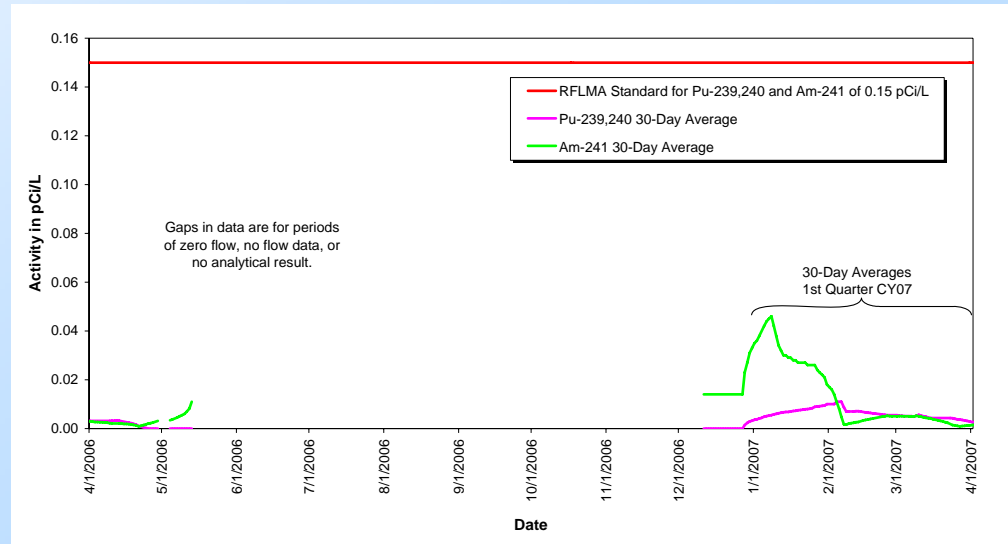
POC GS01

- Plutonium and Americium

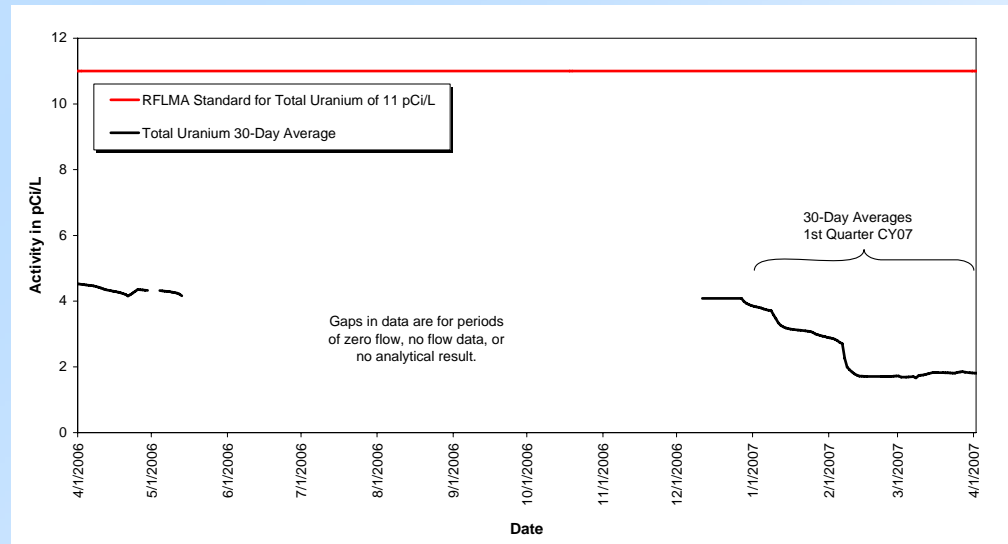
- Total Uranium

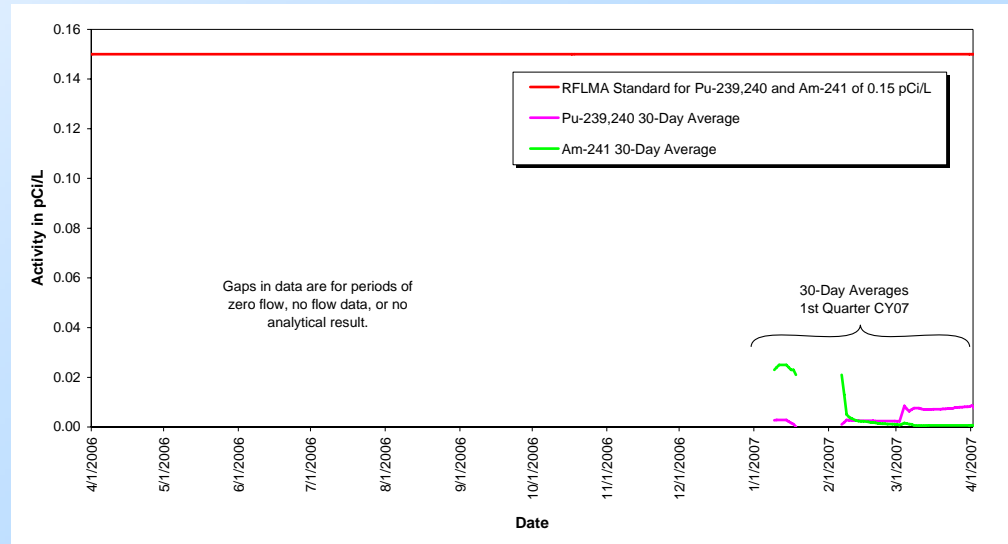
POC GS03

- Plutonium and Americium

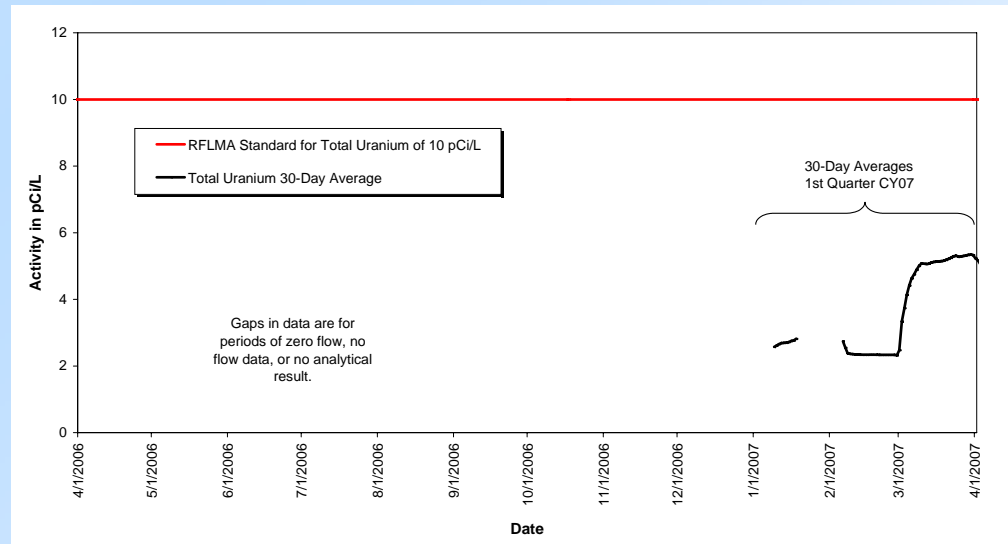
- Total Uranium

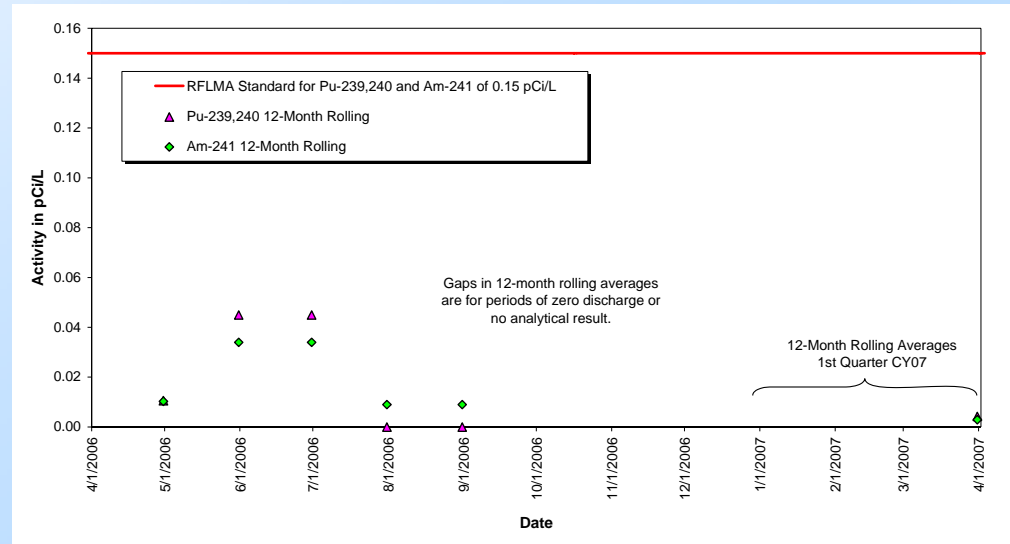
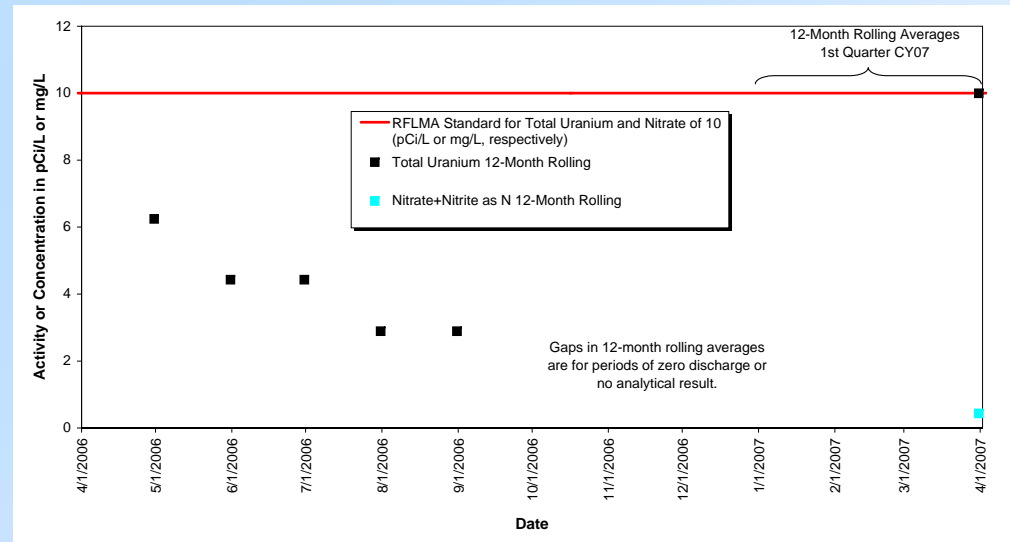
POC GS08

- Plutonium and Americium
- Total Uranium and Nitrate + Nitrite as N

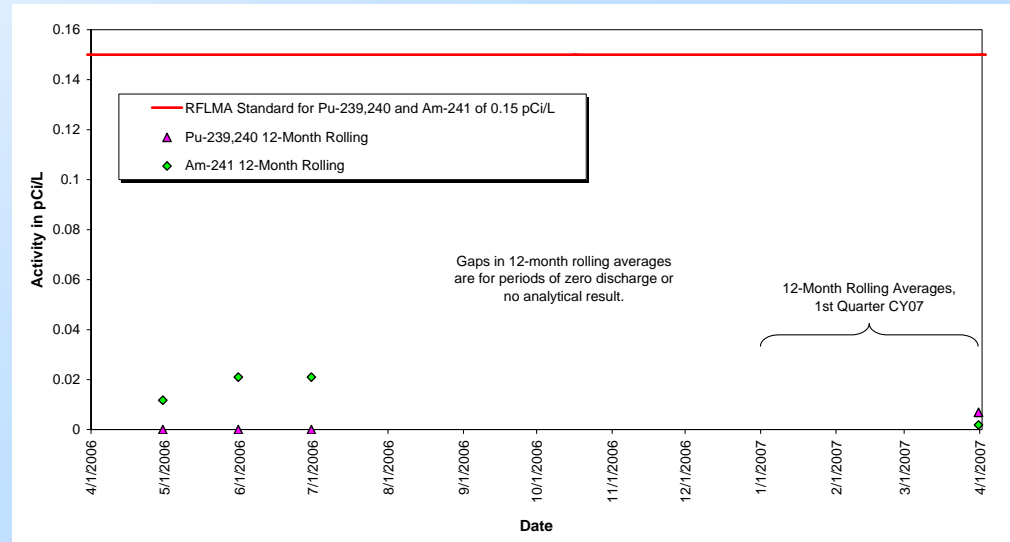
POC GS11

- Plutonium and Americium

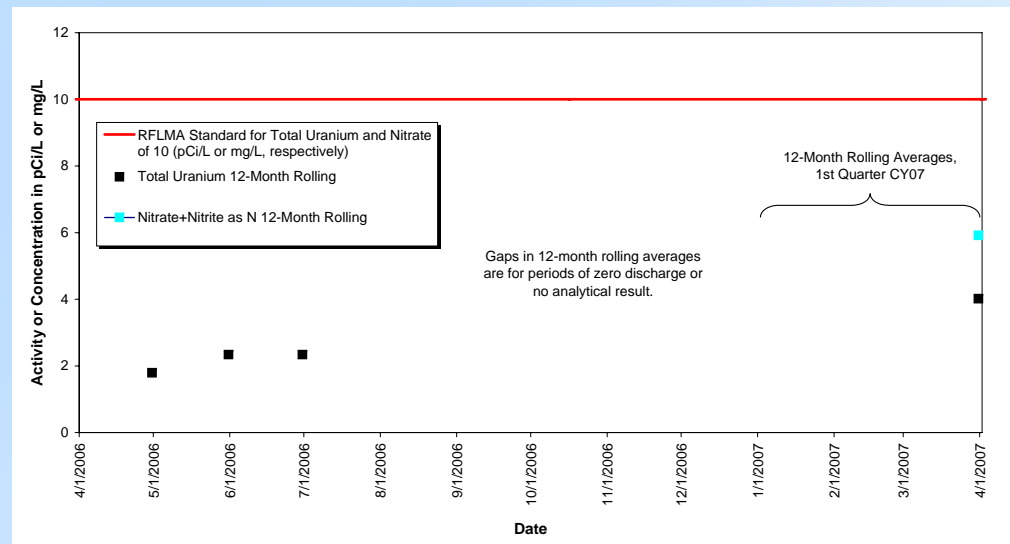
- Total Uranium and Nitrate + Nitrite as N

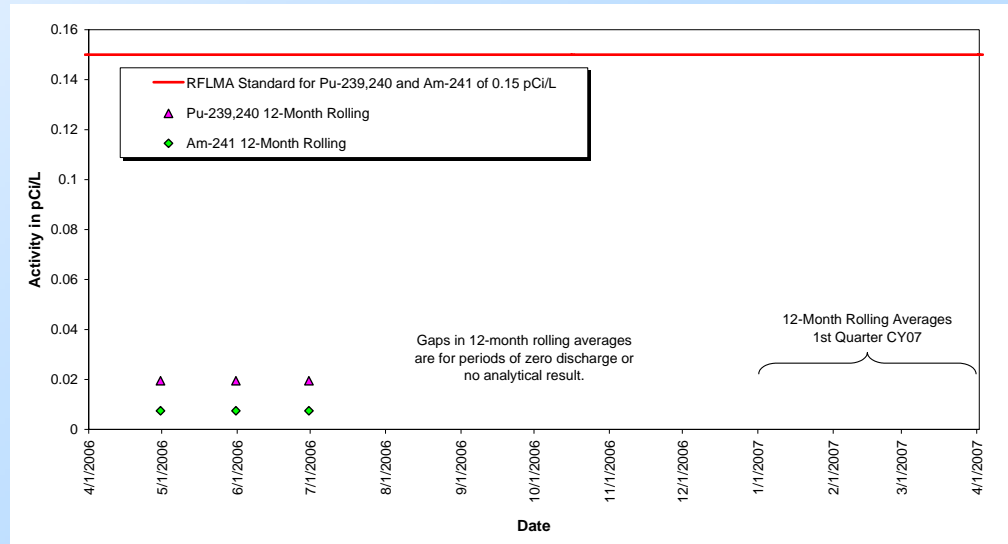
POC GS31

- Plutonium and Americium

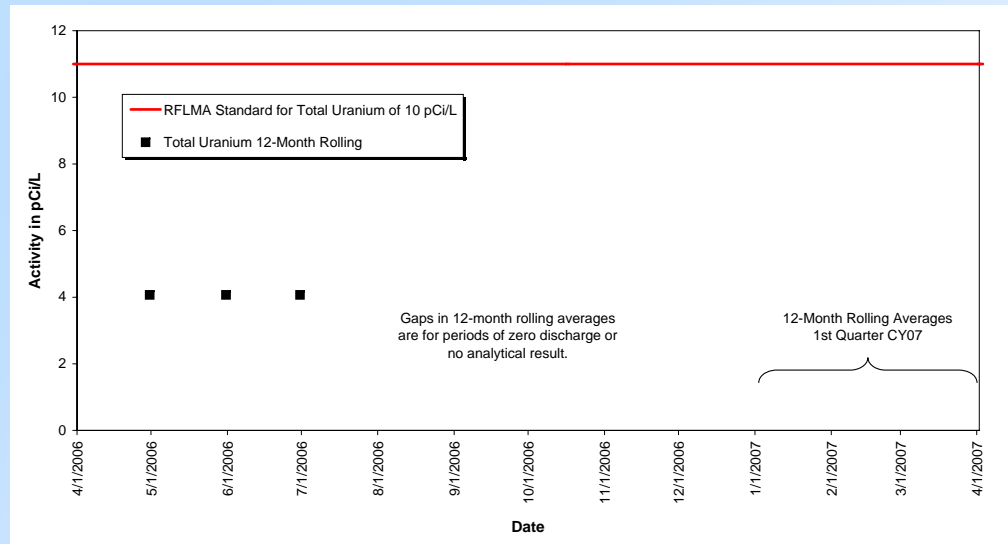
- Total Uranium

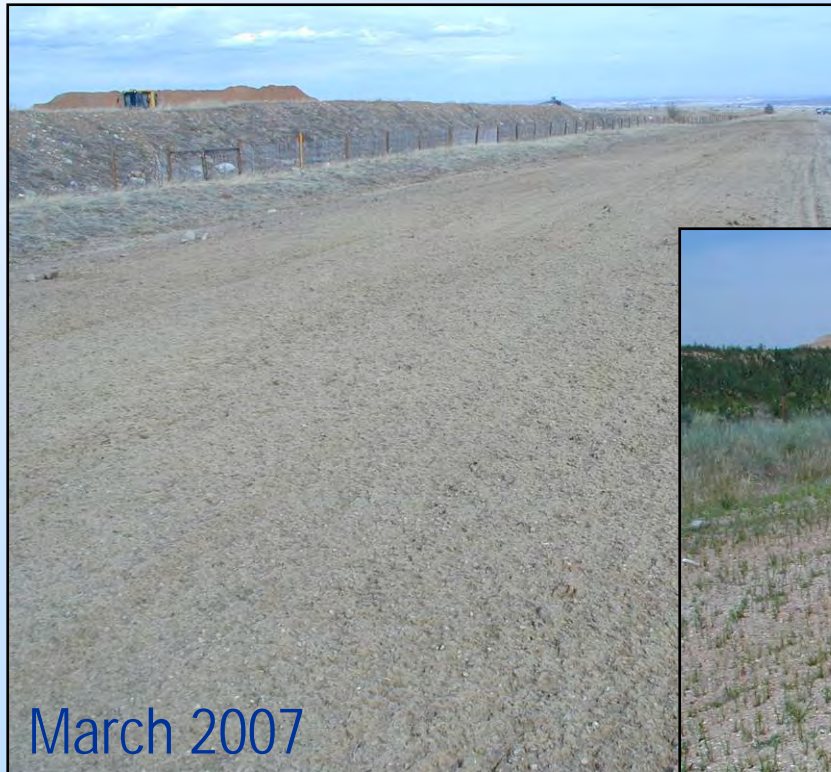
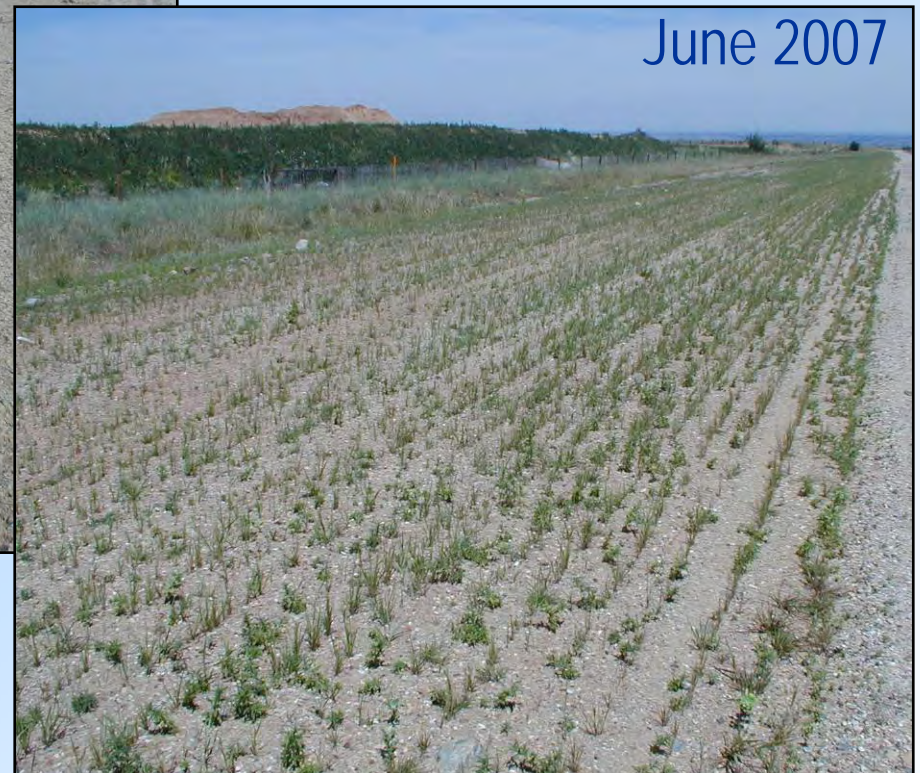
Revegetation

Approximately 69 acres of former roads and parking areas were revegetated using various soil amendments.

March 2007

June 2007

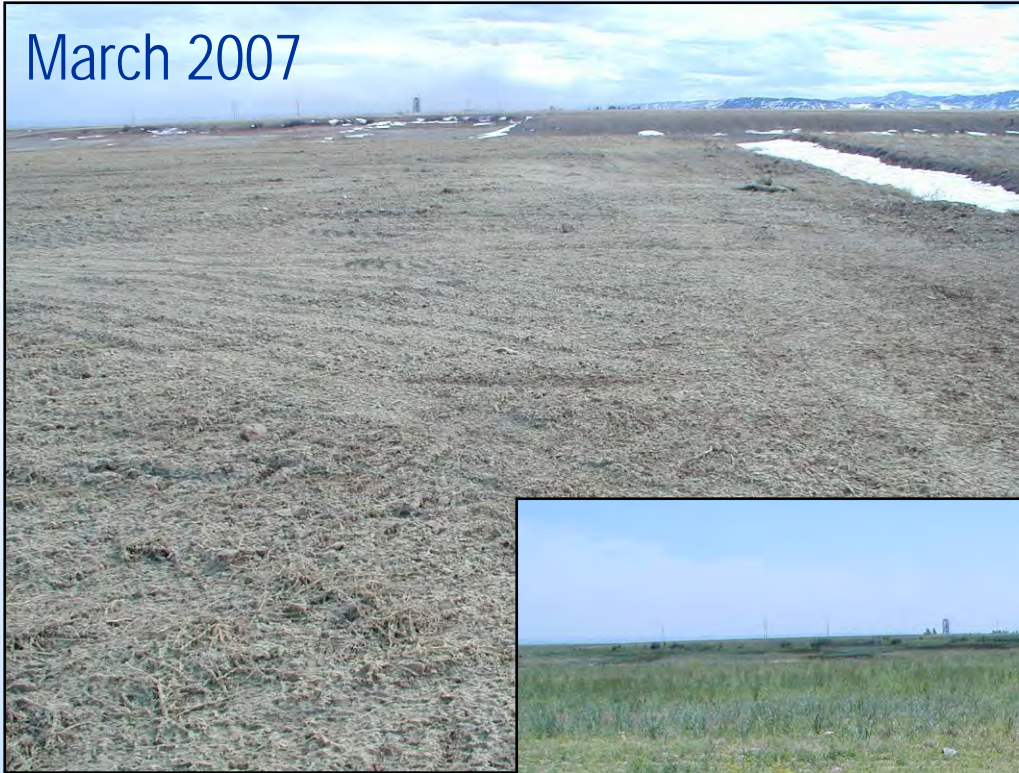
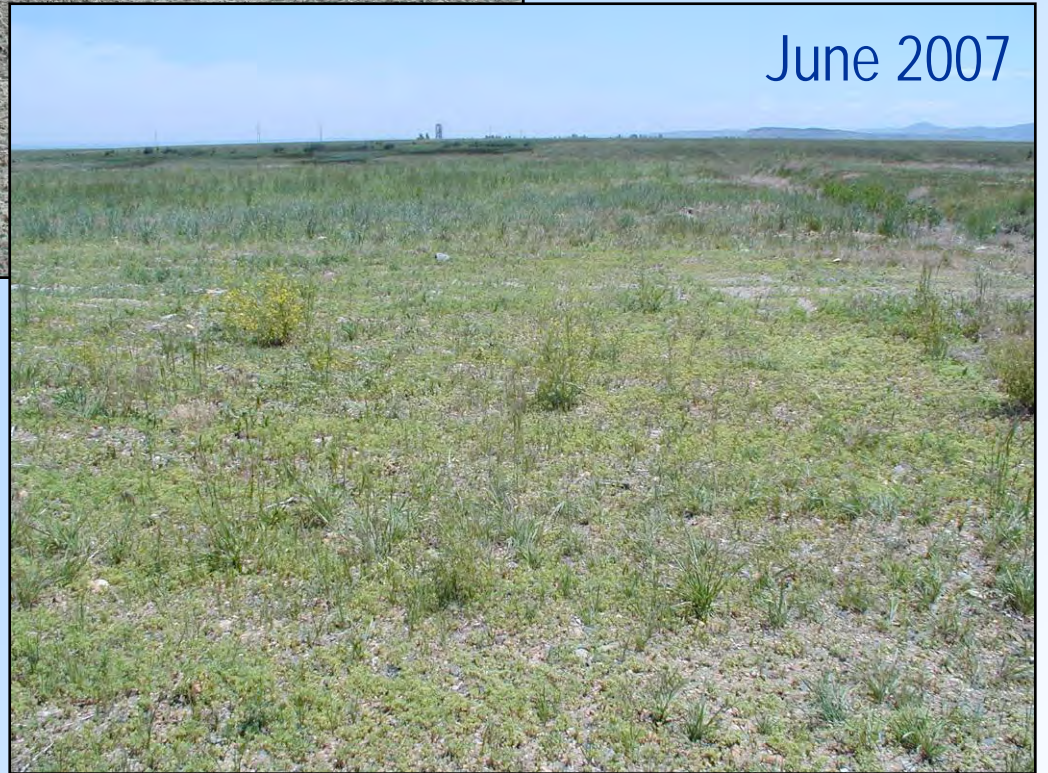
March 2007

June 2007

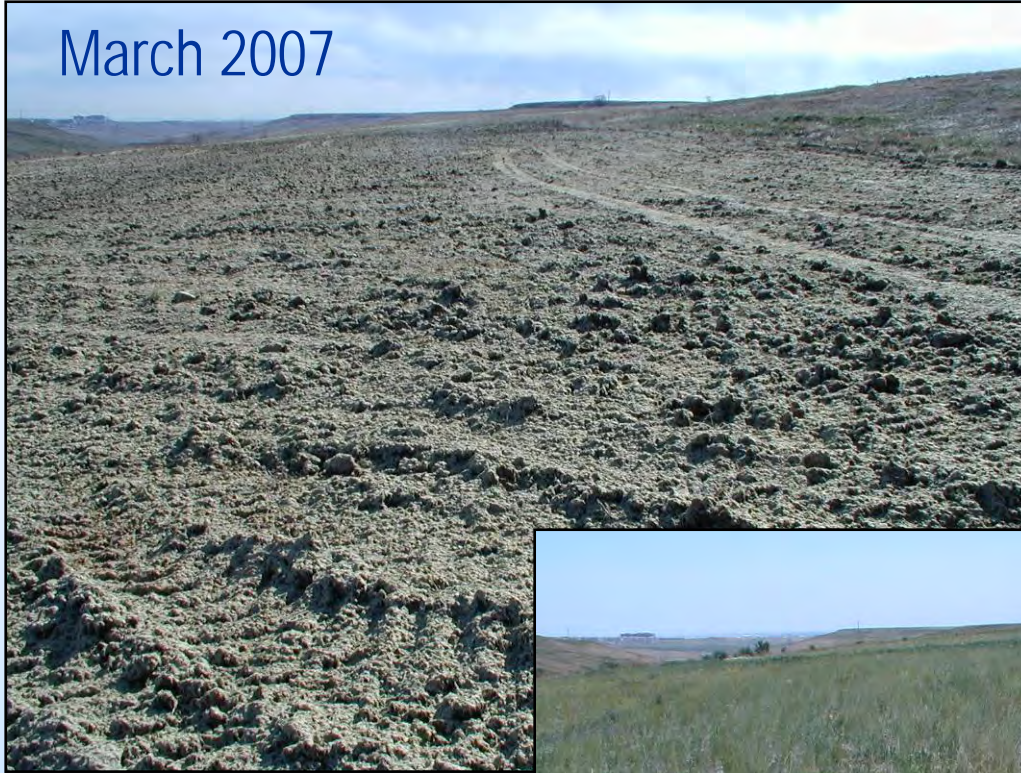
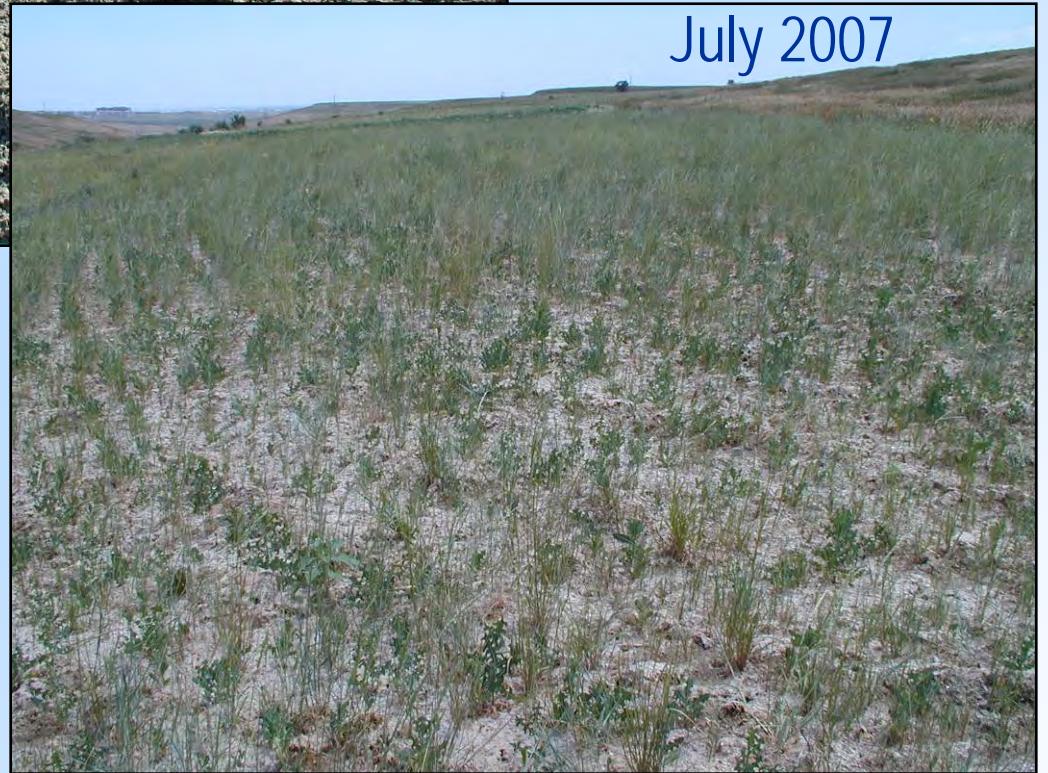
March 2007

July 2007

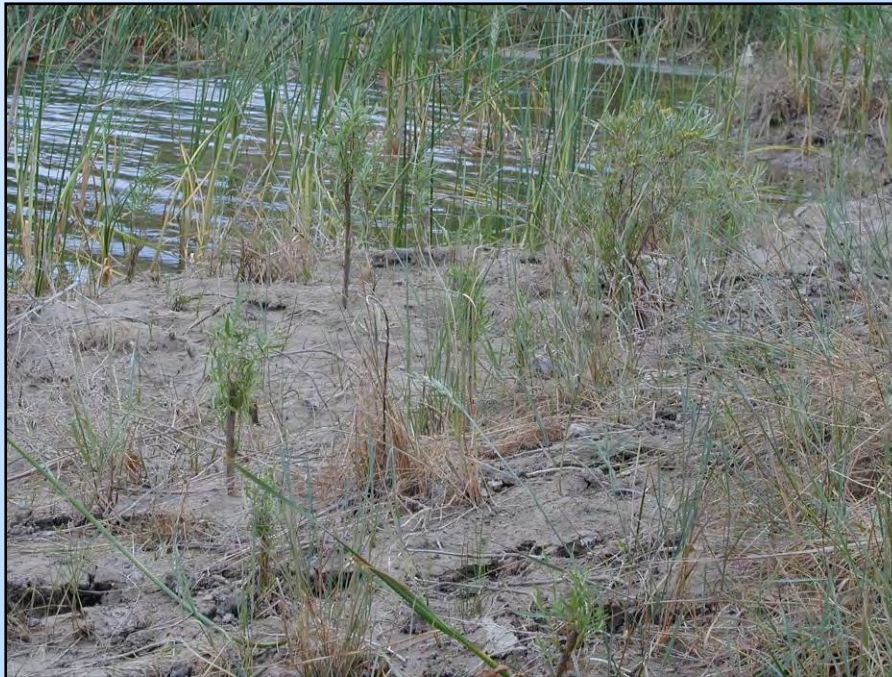
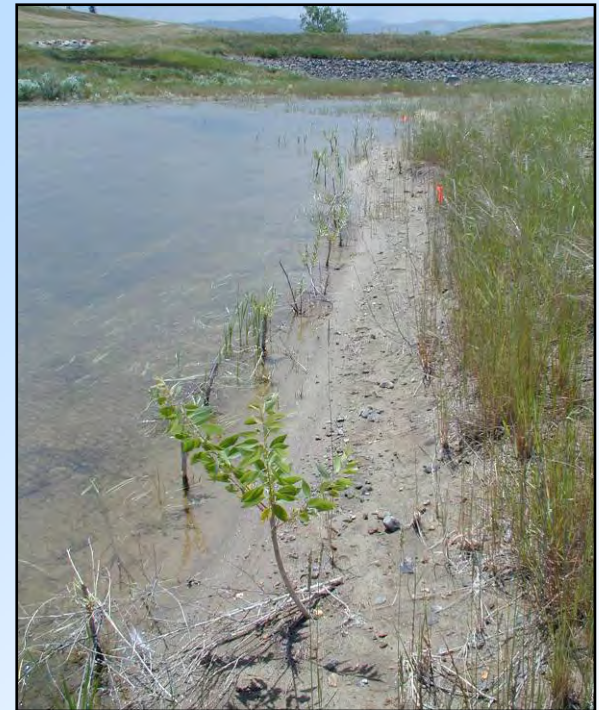
Wetland Plantings

- Approximately 450 bare root shrubs from the Colorado State Forestry Service were planted in and around the mitigation wetlands at the Site.
- 251 coyote willow stakes were installed along the slump line and the north pond edge at the PLF Pond.

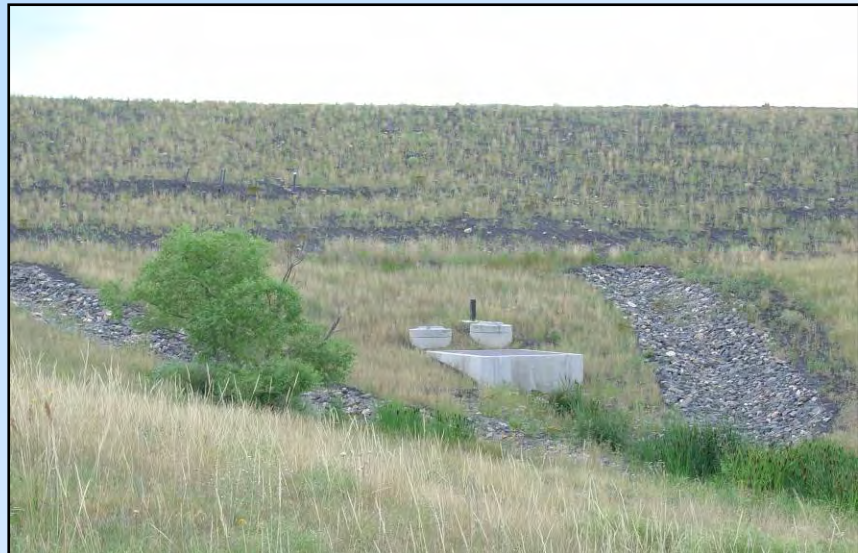
- **Present Landfill**

- Inspections performed January 18, February 14, March 27
- Vegetative cover inspected January 30, February 7, March 14
- Followed prescribed checklist in Monitoring and Maintenance Plan (May 2006)
- New slump was discovered east of Present Landfill on February 13
 - Inspected by Geo-technical engineer same day
 - Staked and mapped with GPS to monitor movement
- **No significant concerns**

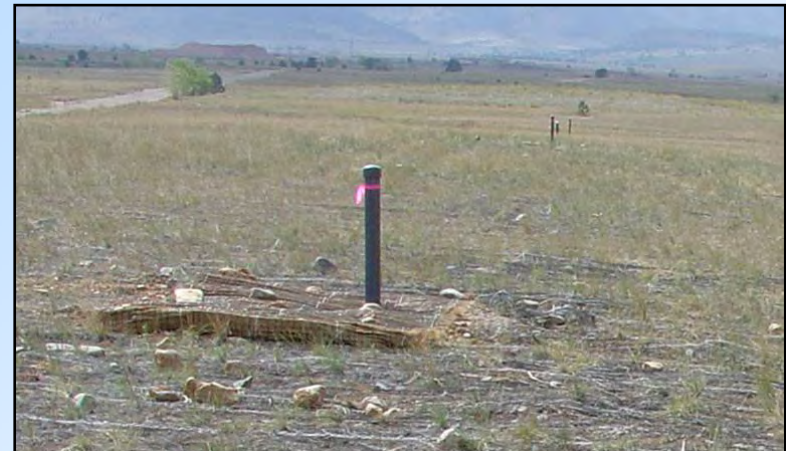
- **Present Landfill - Settlement Monuments**

- Installed in August 2006
- 9 monuments across top of landfill
- 6 monuments on east face of landfill
- Monuments were surveyed in March 2007
 - Second quarterly survey
 - Movement within calculated settlement data

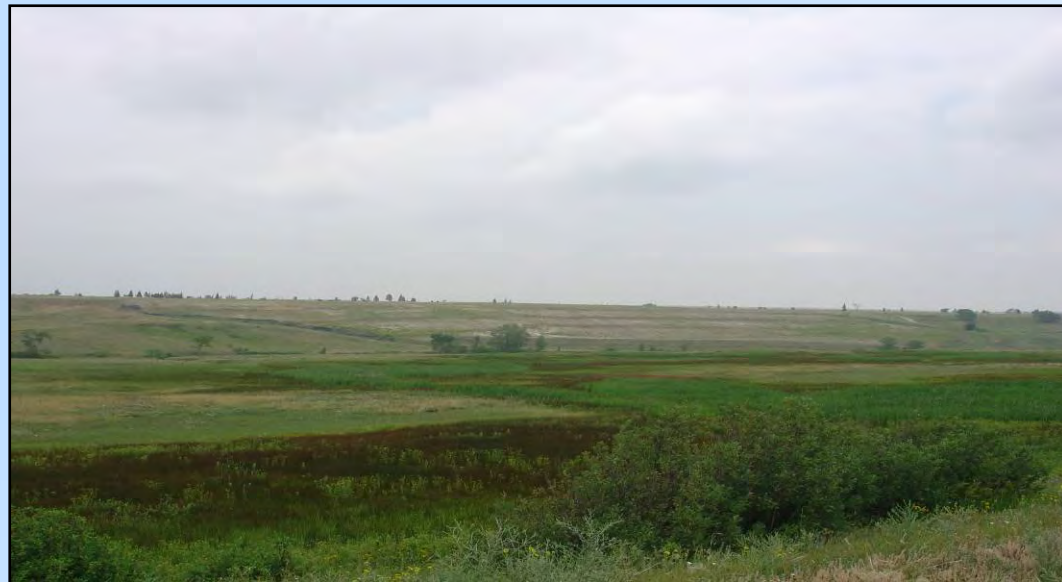
- **Original Landfill**

- Inspections performed Jan 18, Feb 7, March 26
- Veg cover inspected February 7
- Followed prescribed checklist in Monitoring and Maintenance Plan (Feb 2006)

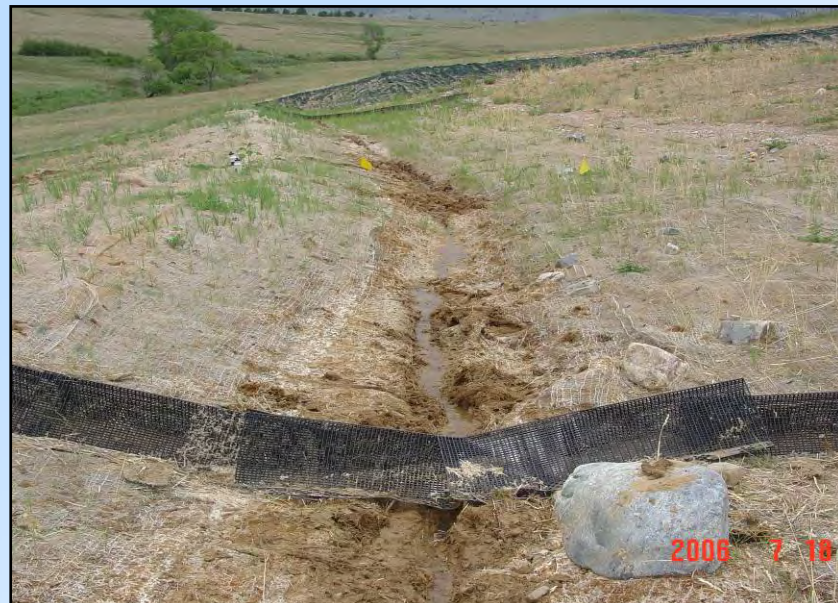
- **Original Landfill**
 - Seeps #4 and #7
 - Both active in 1st Quarter
 - Directed flow along Berm #3
 - Outfall being pinched by WPC Slump

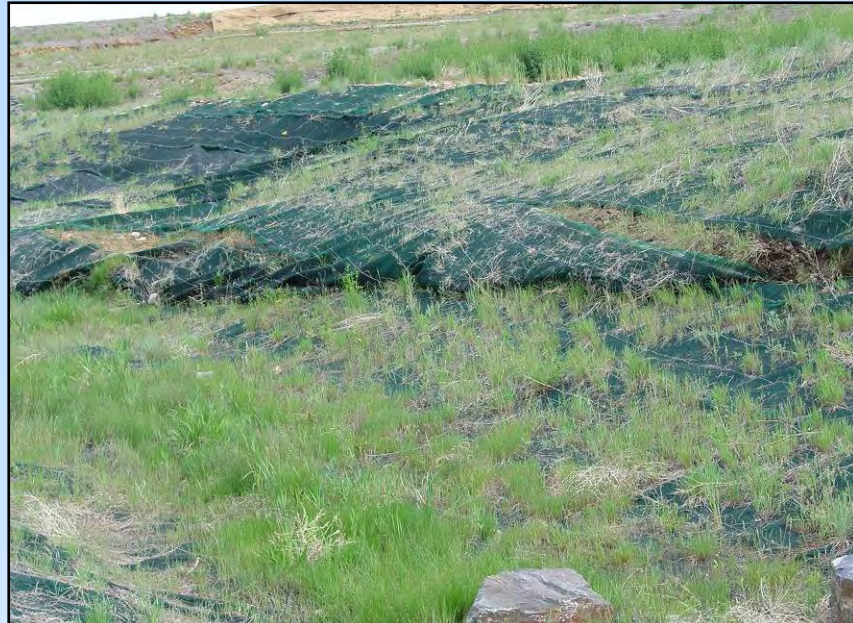
- **Original Landfill**
 - West Perimeter Ditch slump
 - Extended South to Berm #3
 - Field Surveyed with GPS
 - Staked slumping area
 - Photos

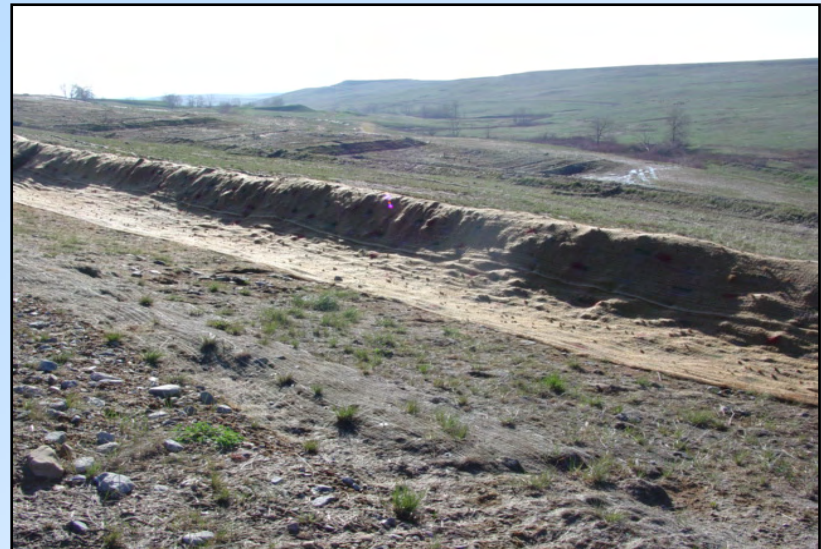
- **Berm #1 Slump**

- Noticed February 7
- Covered with plastic and sand bags
- Submit action plan to CDPHE on March 8
- Filled and compacted berm #1 crack end of March

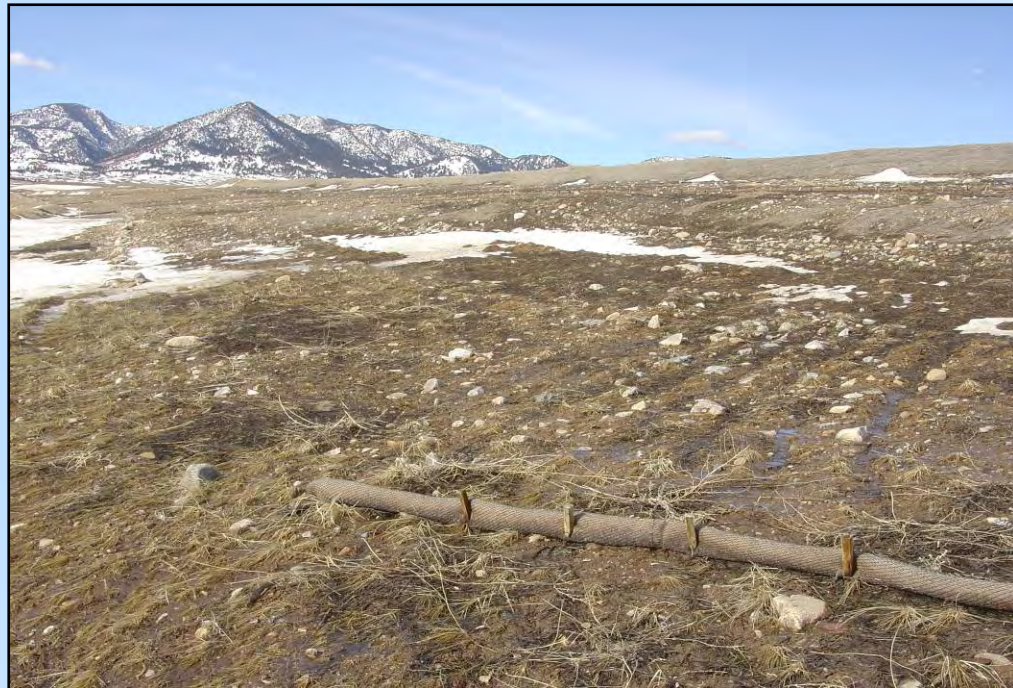
- **Original Landfill – Berm #4 Subsidence**
 - Discovered February 7
 - Staked and Surveyed
 - Inspected by Geotechnical Engineers February 12

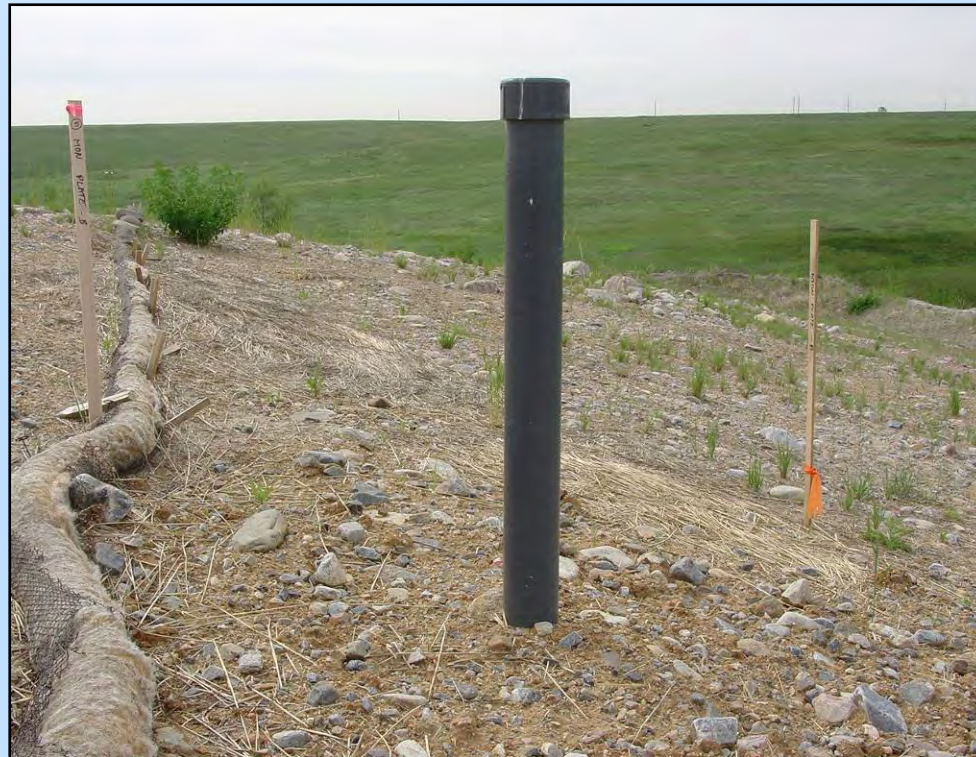
- **Original Landfill - Settlement Monuments**
 - 5 monuments installed in March 2007
 - 3 monuments to be installed when cover dries

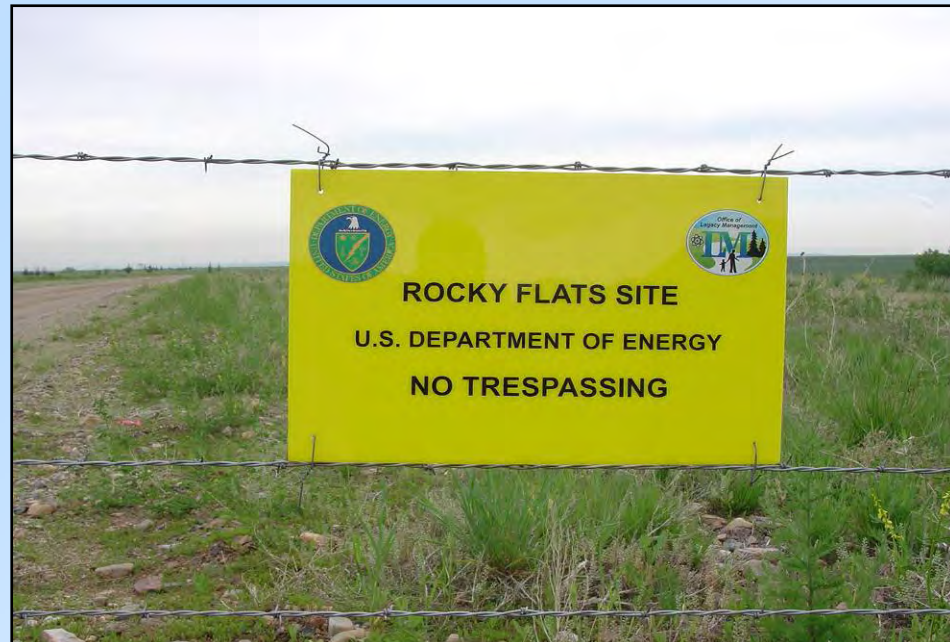
- **DOE Retained Land Fence construction**
 - Work suspended December 20, 2006 due to snow
 - Resumed February 22, 2007
 - Finished March 22, 2007
 - “No Trespassing” signs posted by March 23

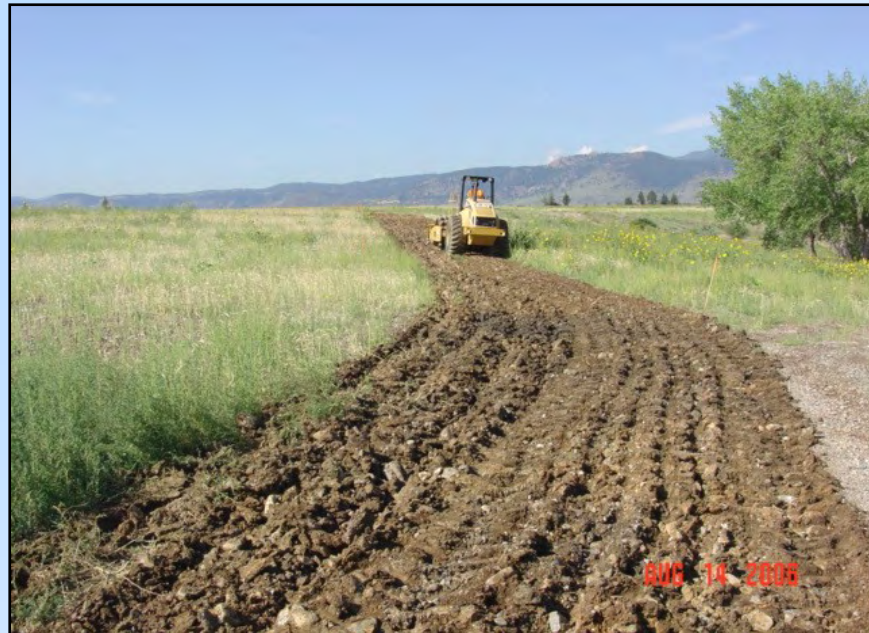
- **Road Upgrades**

- Road Band-Aid Project

- Uninterrupted travel through spring months
 - Started March 21
 - Completed April 3
